GOLDMORR CASE STUDY

Apartment Construction Weather Damage

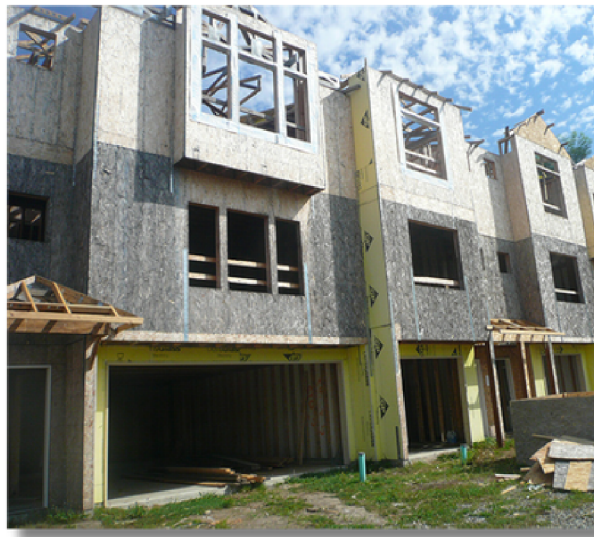
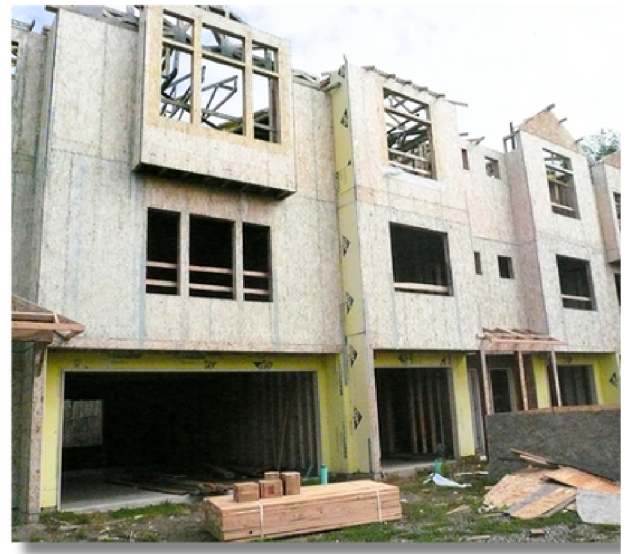
An investment company had reached out to me regarding a property that had been abandoned during the rough-in building stage for approximately 2 years. These four 4-plex units (3-stories high) were built during the rainy season and sat fully exposed to the elements for approximately two years without ever being dried in. Three of the four complexes had the roof and windows installed, while the fourth unit was still in need of the roof and windows. There was visible evidence of surface mold growing on the exterior OSB sheathing, interior OSB sheathing, some stud walls and baseplates, along with the subfloors throughout each of the three levels in all four buildings.

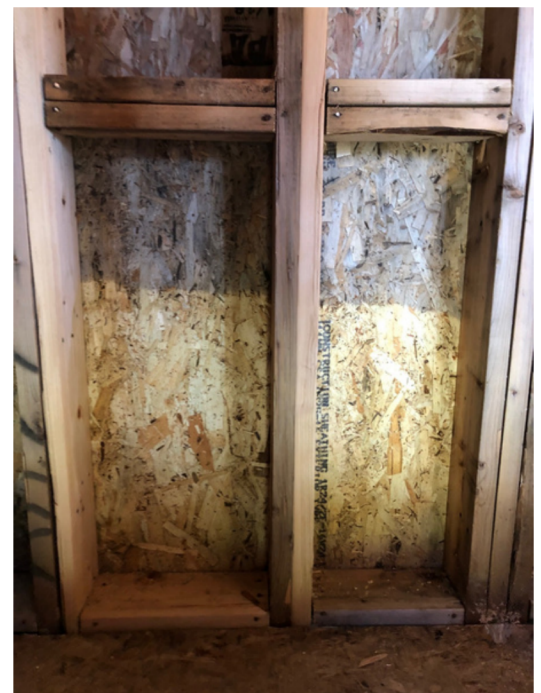
The local building department required that a licensed and bonded company mitigate the mold. During my initial inspection, I took a bottle of Goldmorr GM6000 stain remover and showed several examples of what the wood building materials would look like in comparison with before/after locations identified (see picture image of wall cavity). I also showed an example of how well the trusses would clean up with instant results.

- All interior surfaces were HEPA vacuumed prior to any surface treatment in order to remove any dust, debris, etc.
- All hard surfaces where visible staining and fungal growth were noted were micro-cleaned with a mold stain remover.
- The entire interior of the building was the containment.
- Negative exhaust fans were used to reduce any interior VOC's as a result of the micro-cleaning process.
- All interior spaces were fogged employing a patented, non-mechanical air scrubbing system which uses a biodegradable fogging agent to eliminate airborne mold spores and other particulates.
- Post-testing particulate count reports were taken using a third-party, calibrated particle counter in order to ascertain levels in relation to ISO 14644-1 (International Standards Organization) in each unit and building.
