GOLDMORR CASE STUDY

Home Mold Damage Renovation

It's Always More Than Meets the Eye!

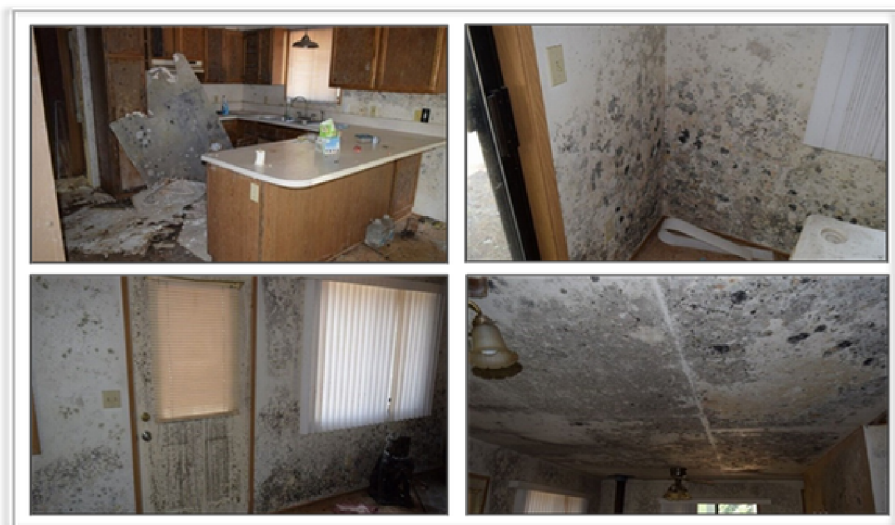
A local general remodel contractor was performing a renovation on a bank owned property that had been left unattended and had significant visible mold growth. As can be seen in the above photos, virtually every surface in the home was covered. The contractor performed what they considered a thorough clean up of the building structure including the removal of most drywall and other interior surfaces that had visible growth. They also “cleaned” the structural elements of the building and then applied a seal coat to what was left as seen in pictures below.

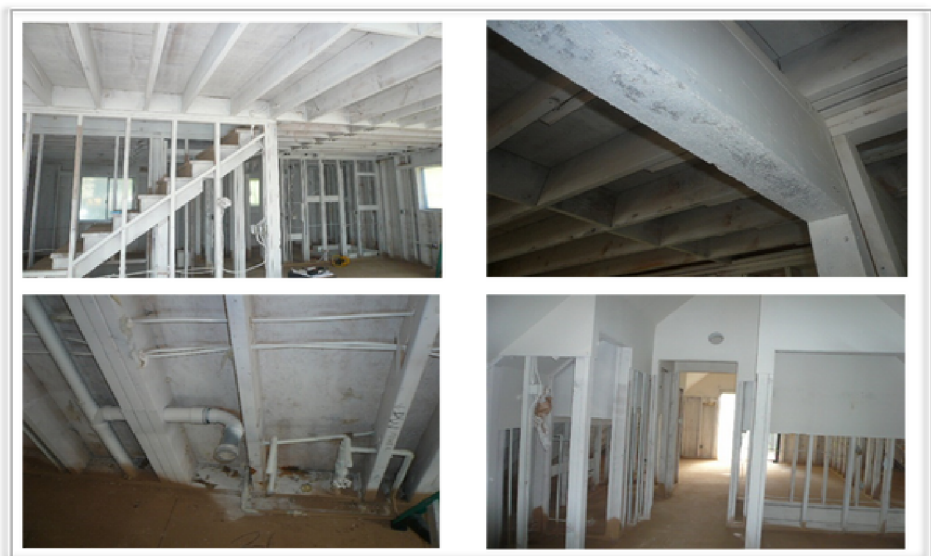
Looks clean right? The Bank, however, wanted more. To their credit they required an air quality clearance before they would accept the renovation. ***That's where Goldmorr came in.***

Every room failed the clearance test. While the contractor had done a relatively thorough job cleaning up the visible mold, they had not taken into account the unseen mold spores that remained in the environment. Mold spores that from a health perspective, would quite likely create more problems than the visible growth alone.

Now the contractor was stumped on how to proceed. We explained that a simple air quality treatment using our GM2000 fogging agent would take care of those unseen spores. It literally took longer to travel out to the job than perform the fogging treatment. The next day a clearance test was performed again with sterling results:
