# It's Always More Than Meets the Eye

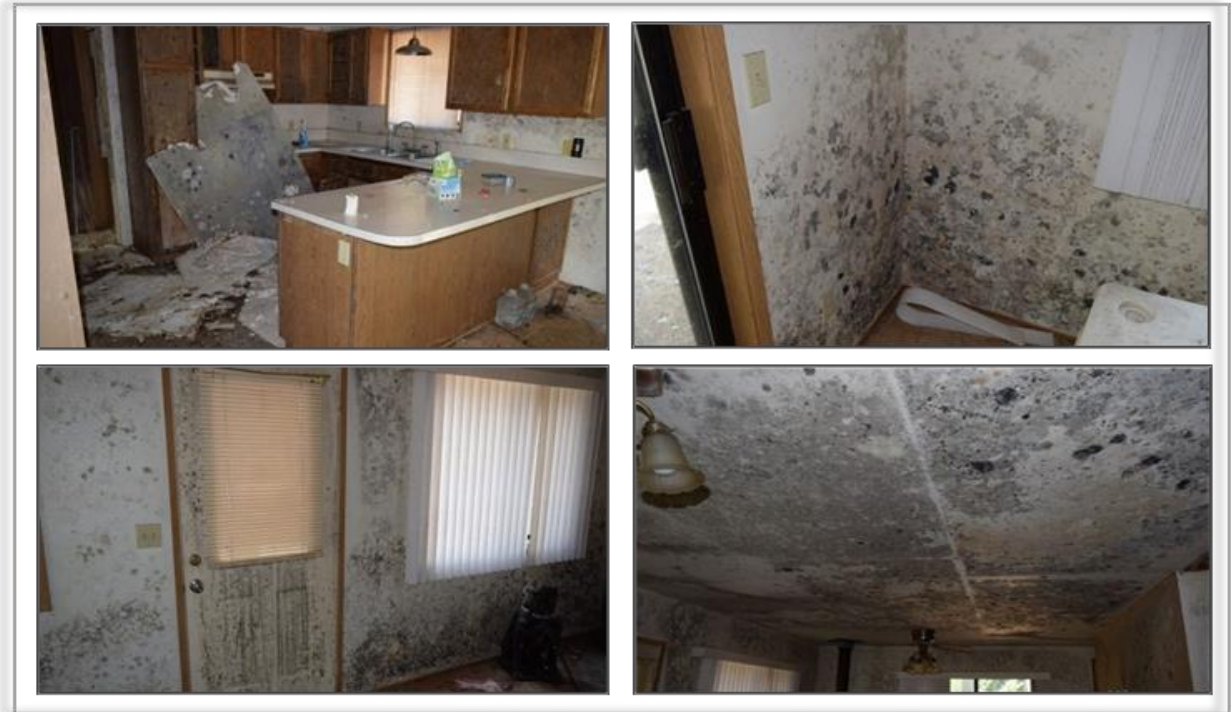
A local general remodel contractor was performing a renovation on a bank owned property that had been left unattended and had significant visible mold growth. As can be seen in the above photos, virtually every surface in the home was covered. The contractor performed what they considered a thorough clean up of the building structure including the removal of most drywall and other interior surfaces that had visible growth. They also “cleaned” the structural elements of the building and then applied a seal coat to what was left.

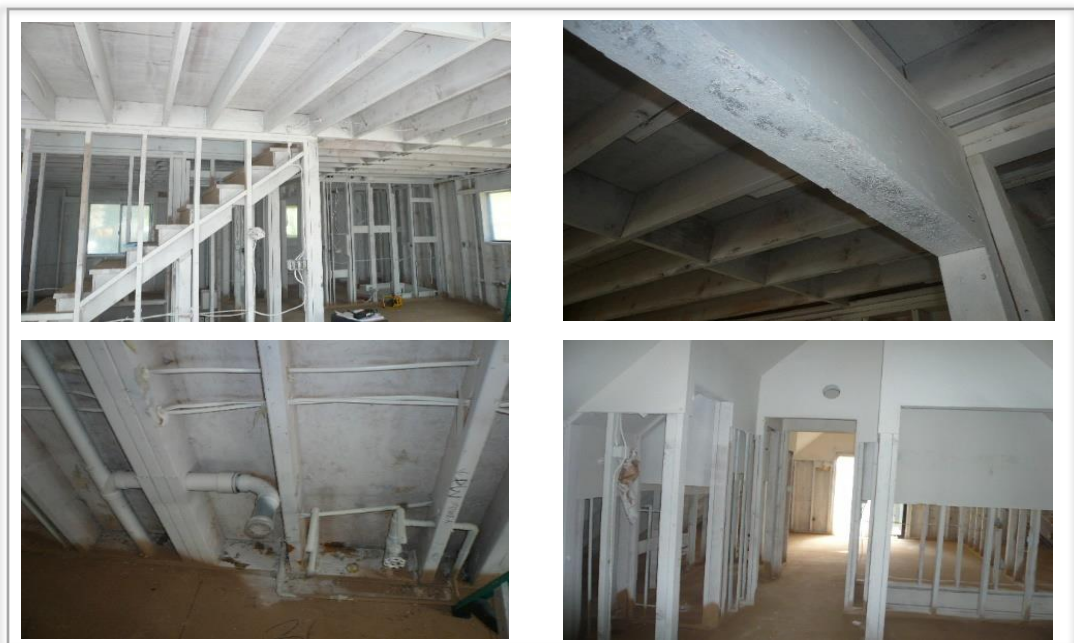
Looks clean right? The Bank, however, wanted more. To their credit they required an air quality clearance before they would accept the renovation. That's where Goldmorr came in. We were initially contracted to simply come out and perform an air quality test. We did this using particle count technologies that are tied into international standards for clean air set by the ISO, WHO and other governmental agencies.

Every room failed the clearance test. While the contractor had done a relatively thorough job cleaning up the visible mold, they had not taken into account the unseen mold spores that remained in the environment. Mold spores that from a health perspective, would quite likely create more problems than the visible growth alone.

Now the contractor was stumped on how to proceed. We explained that a simple air quality treatment using our GM2000 fogging agent would take care of those unseen spores. It literally took longer to travel out to the job than perform the fogging treatment.
