# It's Always More Than Meets the Eye

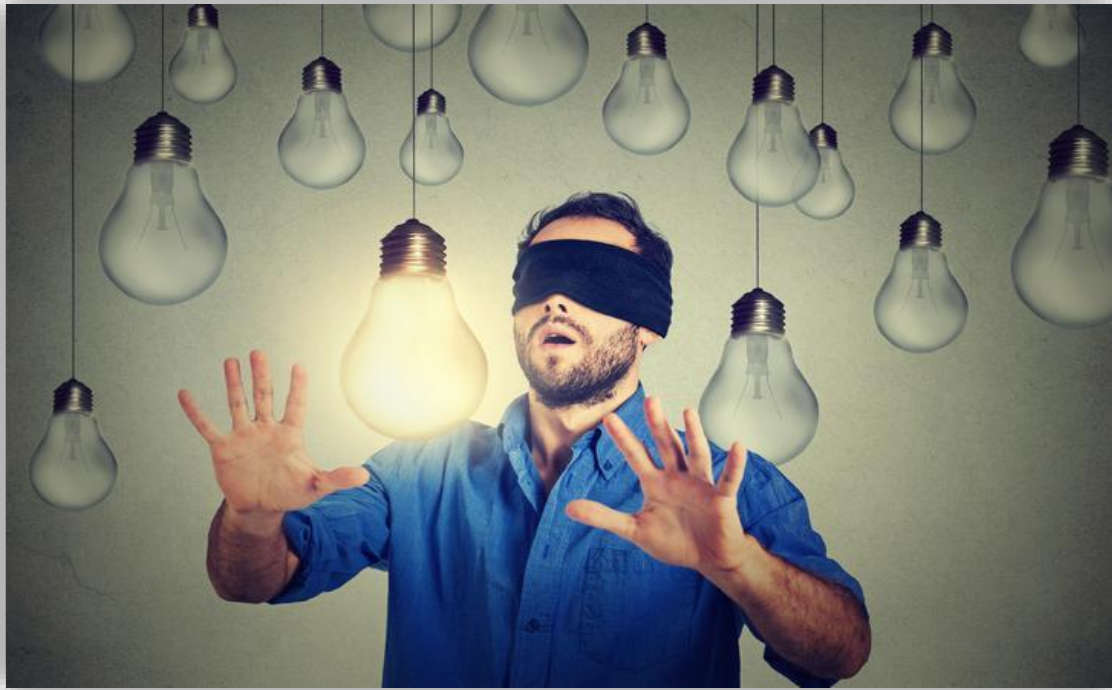
P  
A  
S  
S

Every room passed with flying colors leaving another thrilled and satisfied customer.

Now the contractor was stumped on how to proceed. We explained that a simple air quality treatment using our GM2000 fogging agent would take care of those unseen spores. It literally took longer to travel out to the job than perform the fogging treatment.
